Spec Miata Rear Bump Stop Shim Replacement

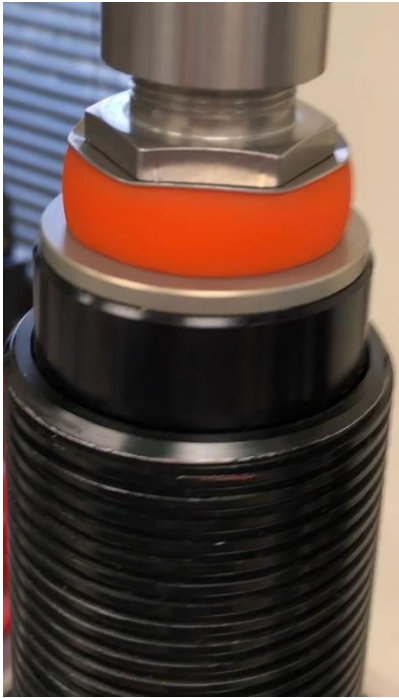
Fig A. Shows current shim/plate (.020" thick) deformation at .125" displacement. The deformation is not a concern because the shim is actually molding itself around the sharp edges of the nut. This does not add risk of bump stop degradation as it continues to protect the stop from the corners of the nut.

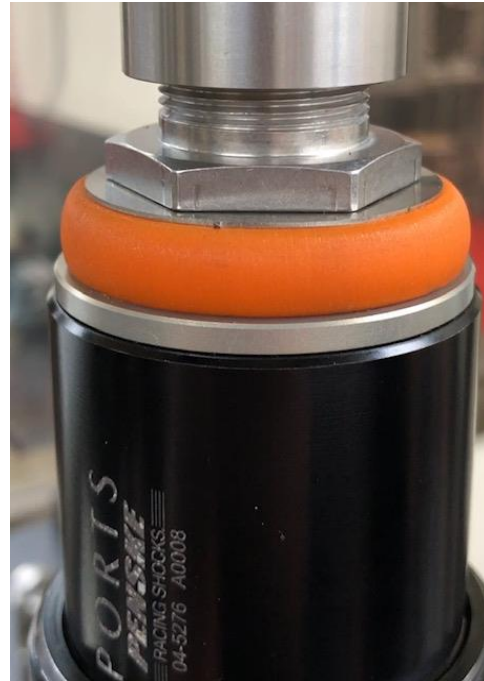
Fig B. Shows optional shim/plate (.030" thick) update. We displaced .300" in this test and shim did not deform. We ran a three-hour endurance run and showed no signs of shim or bump rubber deformation or degradation.

Acquiring the updated shim: Penske Racing Shocks is offering the updated shim. This update can be done at time of first service, picked up at the Mazda Motorsports trackside support program trailer, or by calling - Monday through Friday from 9 am to 5 pm ET - either Mazda Motorsports at 904.426.8757 or Penske Racing Shocks at 610.375.6180. The updated shims will be mailed to customers free of charge for USPS delivery.
