Long Road Racing

Global MX-5 Cup Car Technical Service Bulletin #06-27-2017

<u>REQUIRED</u>: 2017 Global MX-5 Update: Cooling hose clamp update effective immediately

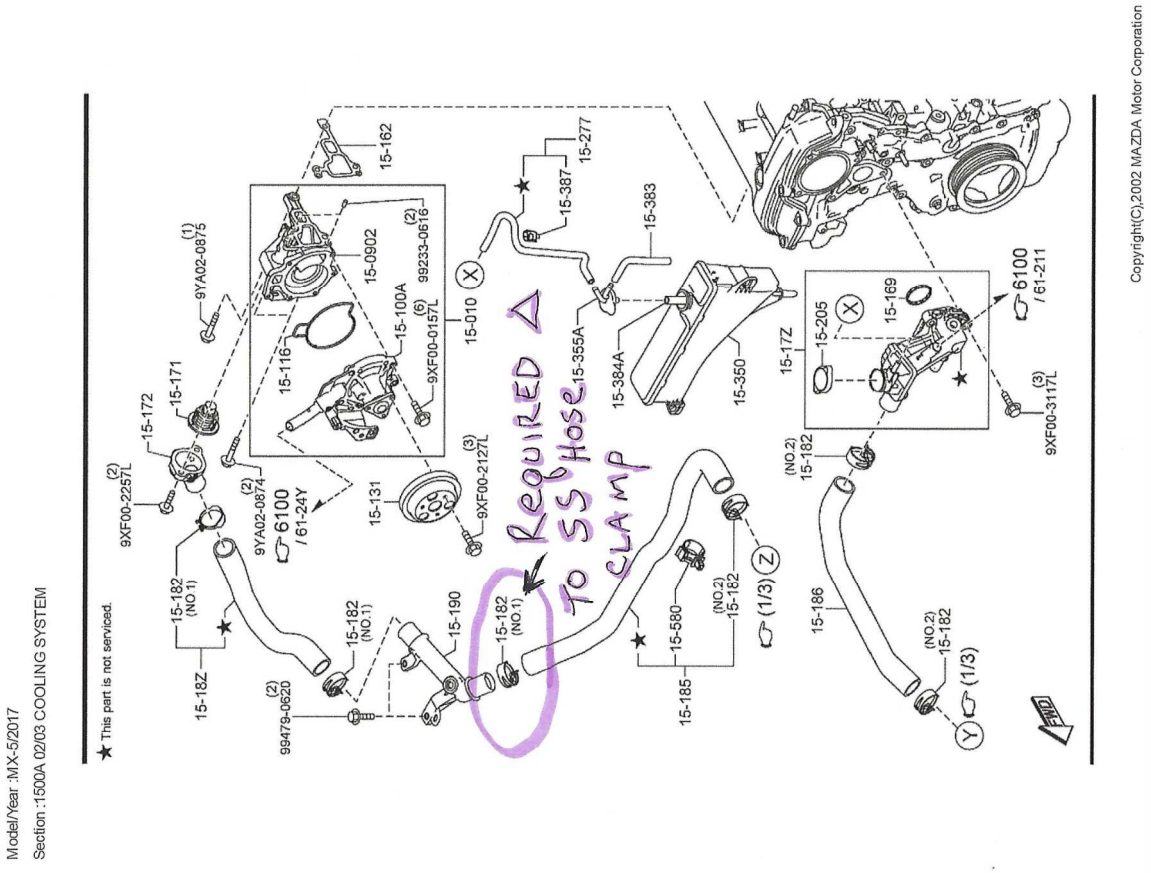
Diagram:

1. A chance of the lower radiator hose clamp may become dislodged (see diagram). The factory spring style clamp is being replaced with a standard stainless steel screw style clamp. **This ONE clamp is a mandatory change**, but all other water hose clamps may be changed to a stainless steel screw style clamps at your option. Purchase the clamp(s) locally.

1. Follow all Mazda service manual instructions for safety, removal and replacement of the water hose clamp(s).
